# **ALEXA LF Software Update Package 4.1**

**for ALEXA LF cameras (SUP\_AlexaLF\_4.1\_43727)**

RELEASE NOTES

May 21, 2019

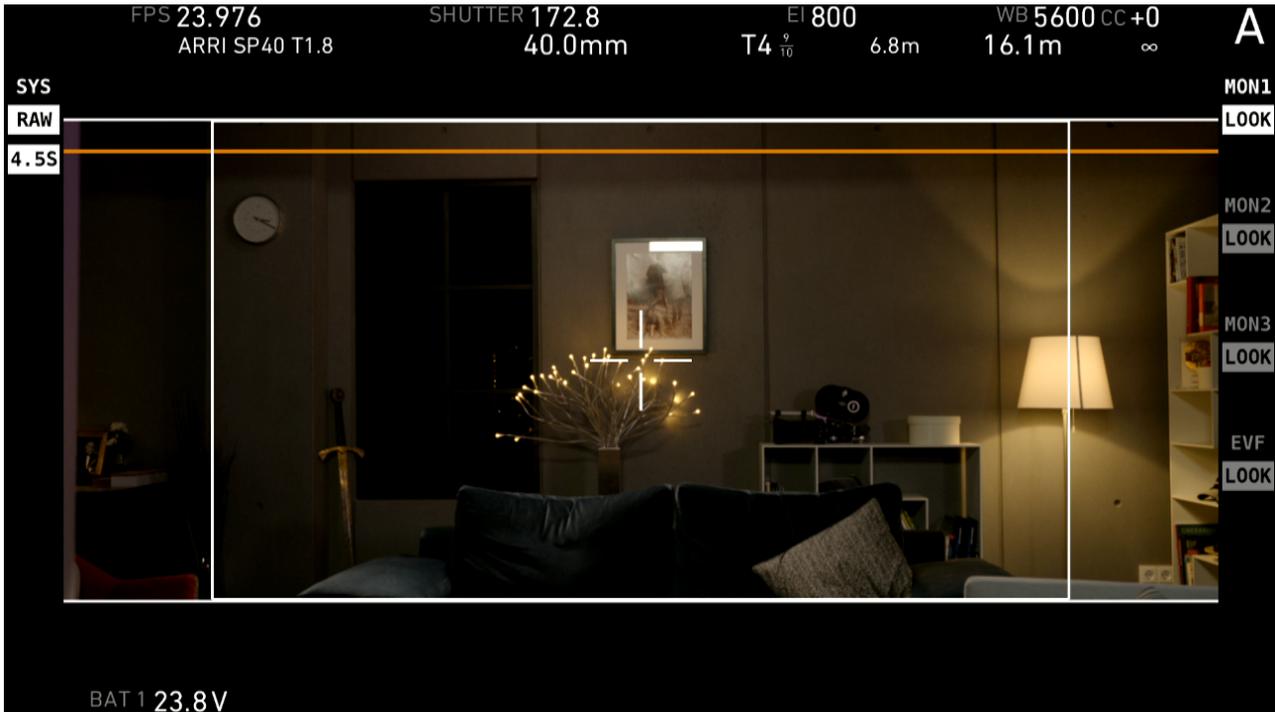
## Orange Line in Frame

A horizontal orange line can appear in the frame where it does not belong (see image above) in the following cases:

- LDS info is turned on while
  - the camera is in LF 2.39:1 sensor mode and
  - an LDS lens is attached and/or LDA is enabled
- LDS info is turned on while
  - anamorphic de-squeeze is on and
  - an LDS lens is attached and/or LDA is enabled

Note 2: The orange line is there on purpose when it appears directly underneath the LDS info, i.e. touching the LDS info area. In that case the orange line indicates that there is image information (that is being recorded) underneath the LDS info. This orange line cannot be removed with the procedure above.

The orange line can be removed with the following procedure (if LDA causes the issue, turn LDA on/off instead of removing the LDS lens):

- Make all the MON OUT settings you need (framelines, center cross, etc.) first. Any change to the MON OUT settings will bring that orange line back
- Remove the lens
- Turn LDS info off. This can be done in MENU > MONITORING > MON OUT <X> > FRAME LINES + STATUS INFO > LDS INFO
- Wait 10 seconds
- Turn LDS info back on
- Re-attach the lens

Note 1: Unfortunately, the line comes back after each camera reboot or when any changes to the MON OUT settings are made.
