ALEXA 35 Xtreme

Software Update Package SUP 5.0.1

RELEASE NOTES

September 1, 2025

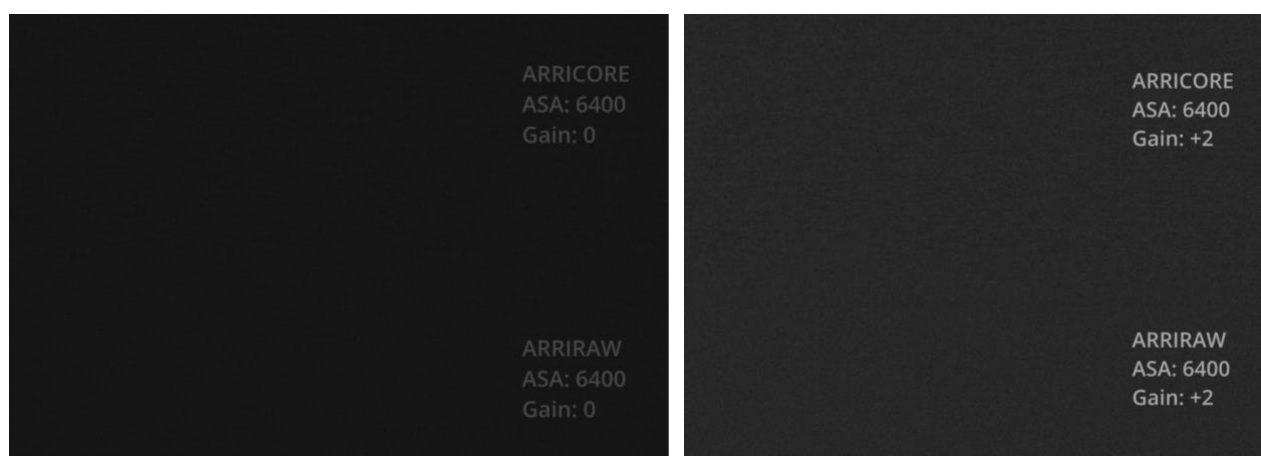
Horizontal Noise in ARRICORE at High EI

In comparison to ARRIRAW, ARRICORE recordings currently have slightly increased noise with a horizontal pattern when shooting at EI 6400 or when shooting at lower EIs and then increasing the image brightness in post. See sample images on next page.

Shoot at or below EI 2560.

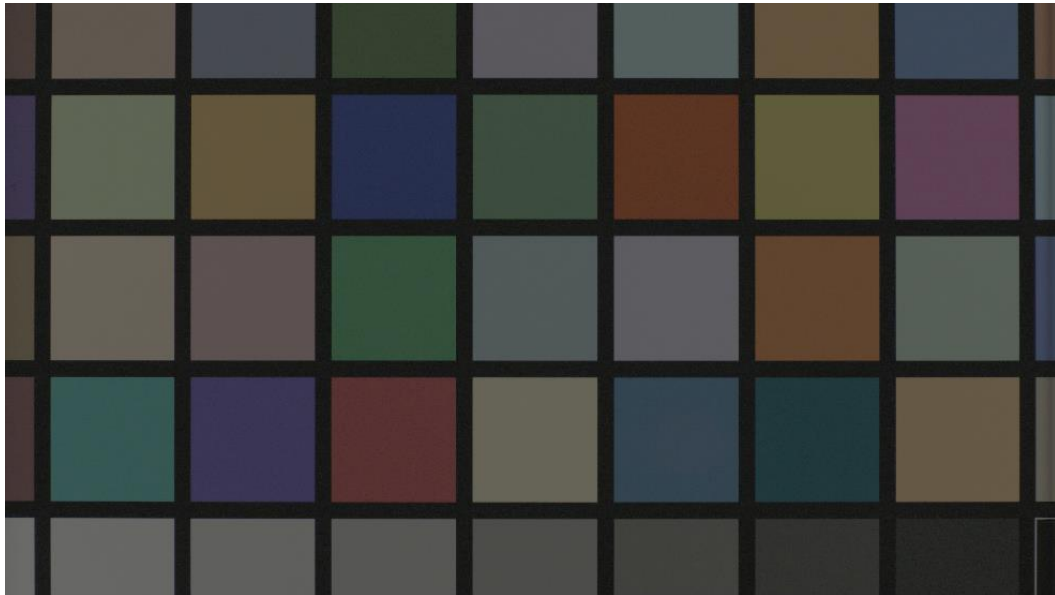
Edge Shadow Artifacts During ARRICORE Playback

When ARRICORE recordings are played back by the camera, they show a shadow or reflection of the image on the image borders, most often visible on the right and left image edges (see right edge of the sample image below). This shadow is not visible in the recording or in the live monitoring/viewfinder image.

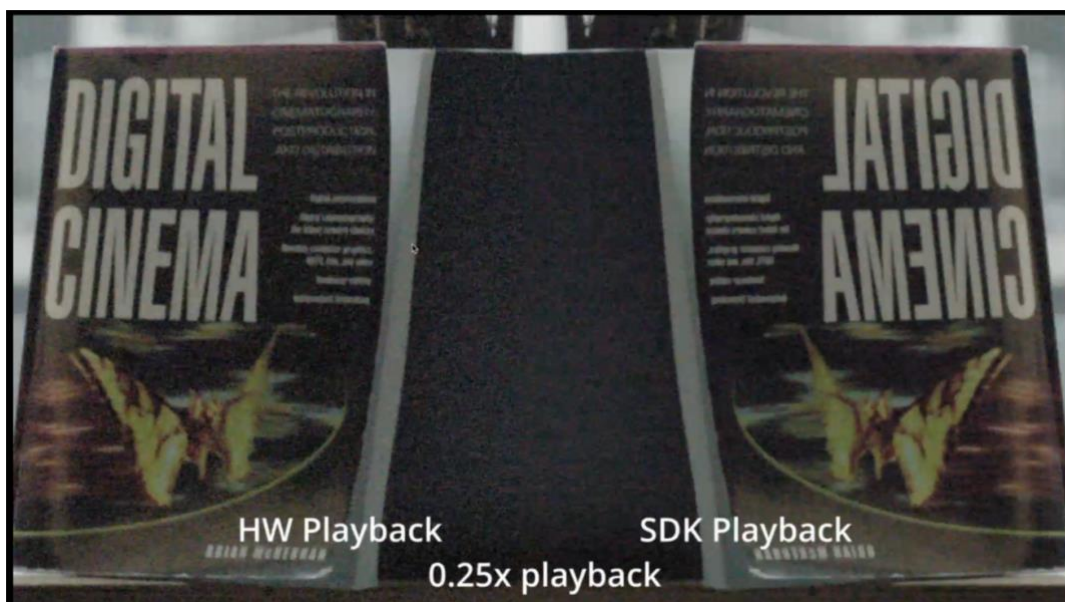
Increased Noise During In-Camera ARRICORE Playback

When ARRICORE recordings are played back by the camera, they show more noise than is actually in the recording and also more noise than is visible in the live monitoring/viewfinder image. In the image below the playback is on the left (HW Playback), and the ARRICORE file as decoded by the ARRI Reference Tool is on the right (SDK Playback).

Don't judge ARRICORE noise based on in-camera playback. If in doubt, use the ARRI Reference Tool to decode sample ARRICORE clips to check on noise levels.
