WVS Software Update Package 4.3.28

**For HD video transmitter in ALEXA LF and ALEXA SXT W,
WVT-1, WVR-1 and WVR-1s**

RELEASE NOTES

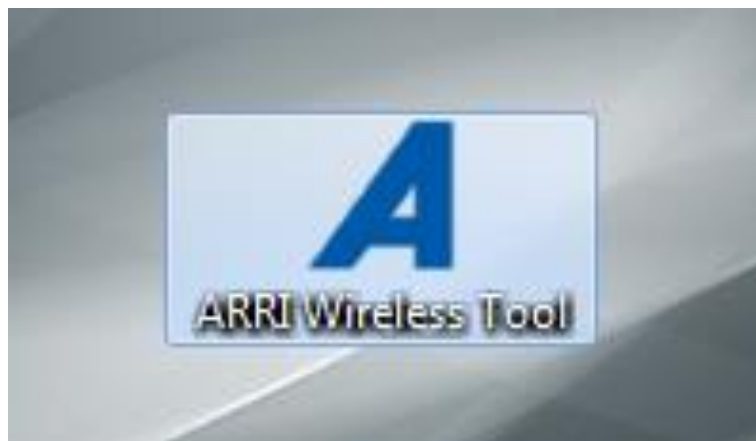
Start the ARRI Wireless Tool software.

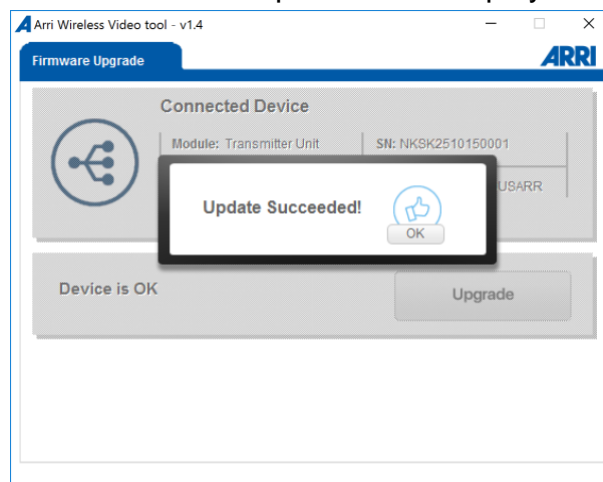
- The upgrade process may take up to five minutes. The device will restart automatically. Once the update is finished, a pop-up will be displayed.
- Click OK to confirm. The device data is updated and displayed.

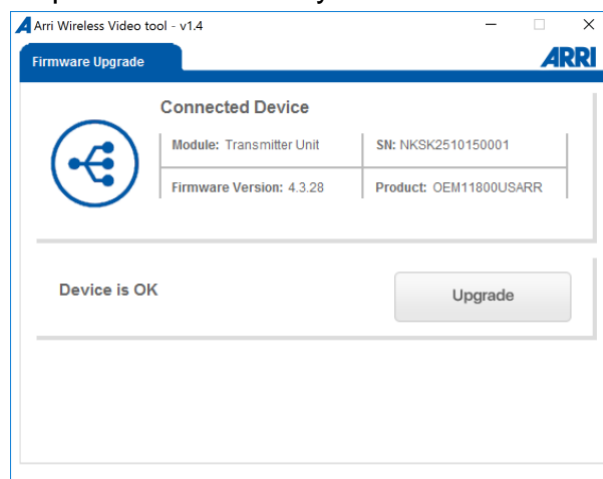
- The firmware has been updated successfully.
