## ALEXA Mini SUP 5.3

Software Update Package SUP 5.3.23

RELEASE NOTES

Date: June 19<sup>th</sup>, 2018

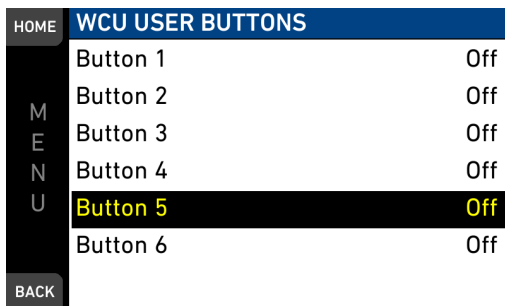
MENU > User buttons > WCU user buttons > Button 5/6

The ALEXA Mini now supports assignment of WCU-4 user buttons 5 and 6.
