# TRINITY 2 SUP 1.4

## Software Update Package 1.4

### RELEASE NOTES

We hereby announce the release of the Software Update Package SUP 1.4 for the RCP-3 and TRINITY 2 head.

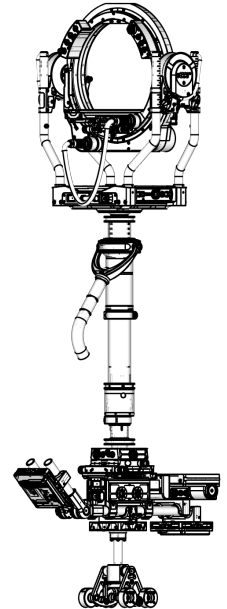
Park the fully prepared rig in the docking bracket.

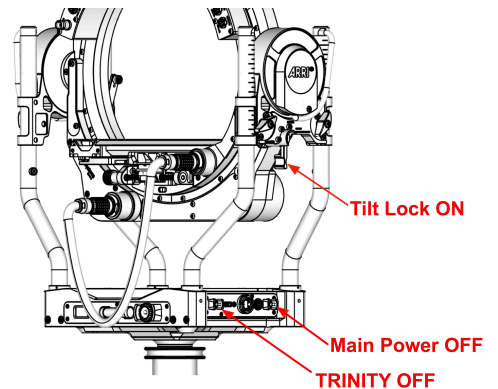
#### TRINITY 2 Head

1. Lock the **Tilt Lock!**
2. Switch **OFF** Main Power
3. Switch **OFF** TRINITY

Make sure the TRINITY 2 head is **powered off** while the RCP-3 is being updated.

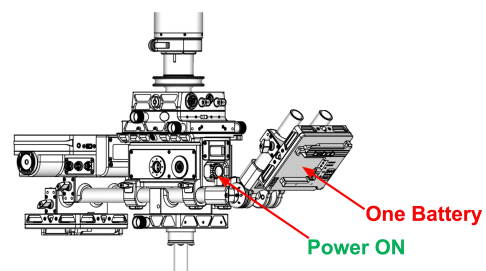
## Battery Hanger Preparations

4. Place minimum one battery.
5. Switch **ON** the Battery Hanger.

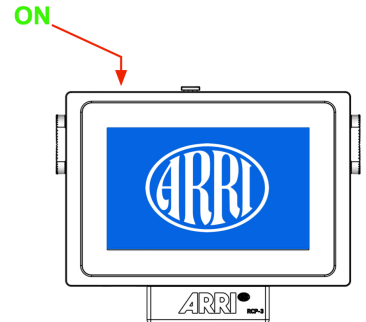
1. Switch **ON** the RCP-3.

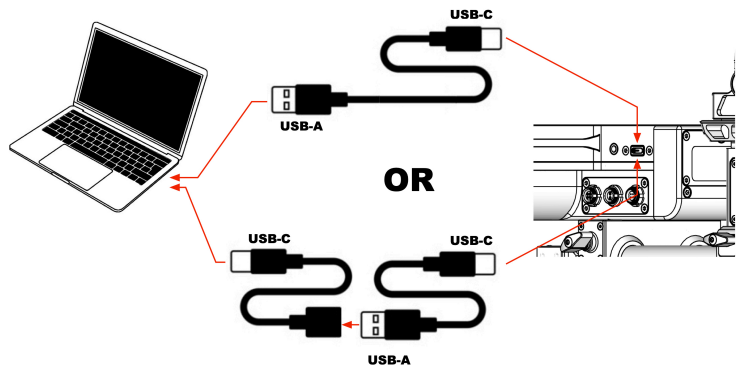
## Connect the USB Cable to the RCP

2. Connect the USB cable to the RCP-3.

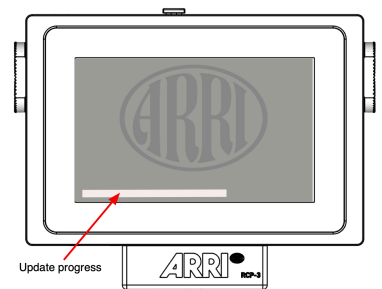
- 6. Once the software file has been uploaded into the RCP-3, the RCP-3 will **reboot** and a **gray screen** and the progress bar will appear.

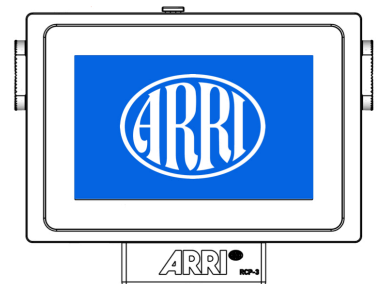
- 7. After the software update has been successfully completed, the RCP-3 restarts and the standard **blue** start screen is displayed.

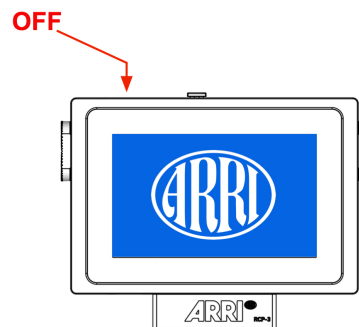
8. Switch **OFF** the RCP-3 first!

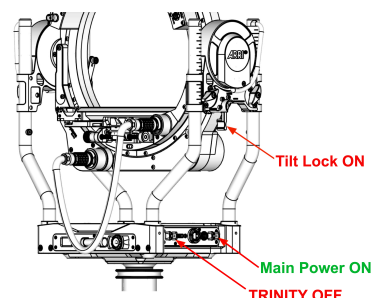
9. Switch **ON** the TRINITY 2 **Main Power**.

Keep the TRINITY switched **OFF!**

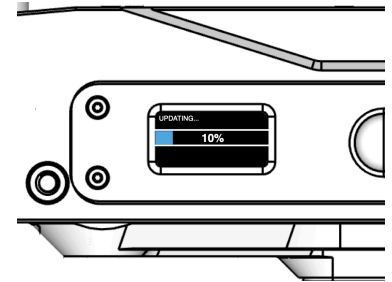
13. Once the software file has been uploaded into the TRINITY 2 head, the TRINITY 2 will reboot and the progress bar will appear in the display at the back.

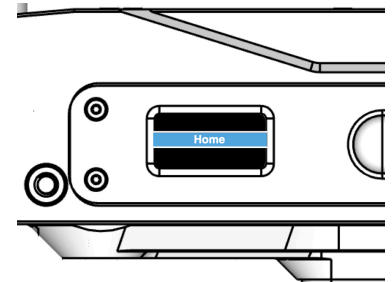
14. After the software update has been successfully completed, the TRINITY 2 head restarts and the standard start screen is displayed.

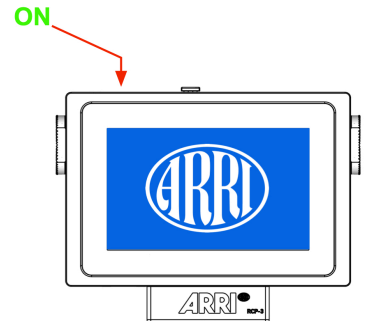
1. Switch **ON** the RCP-3.

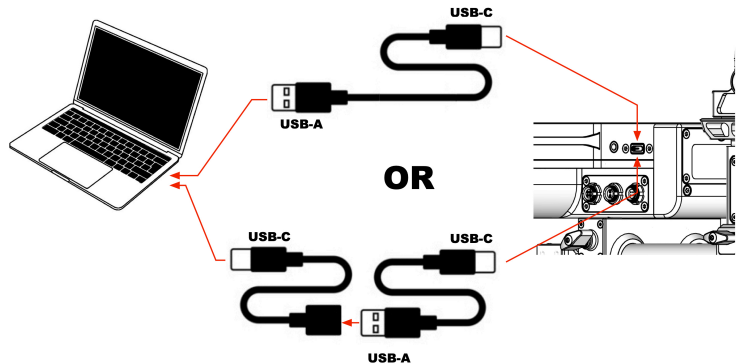
## Connect the USB Cable to the RCP

2. Connect the USB cable to the RCP-3.

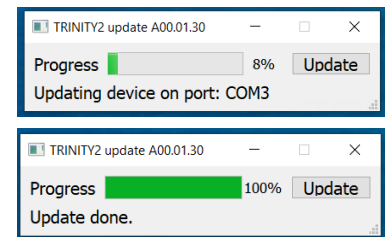
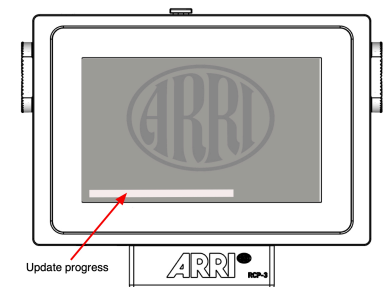
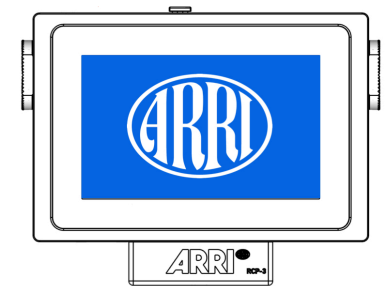
8. During the update, the progress and the used COM Port is displayed on the screen.
9. Once the software file has been uploaded into the RCP-3, the RCP-3 will **reboot** and a **gray screen** and the progress bar will appear.
10. After the software update has been successfully completed, the RCP-3 restarts and the standard **blue** start screen is displayed.

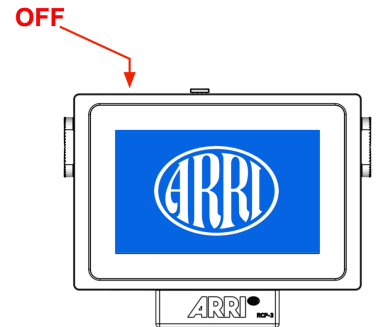
11. Switch **OFF** the RCP-3 first!

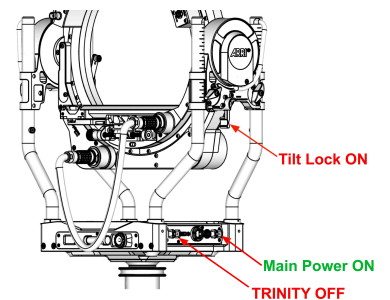
12. Switch **ON** the TRINITY 2 **Main Power**.

Keep the TRINITY switched **OFF!**

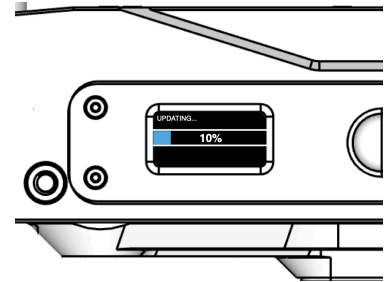
16. Once the software file has been uploaded into the TRINITY 2 head, the TRINITY 2 will reboot and the progress bar will appear in the display at the back.

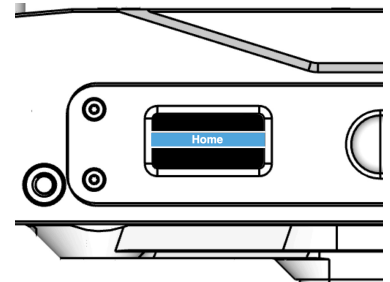
17. After the software update has been successfully completed, the TRINITY 2 head restarts and the standard start screen is displayed.
