ARRI Electronic Control System Release Notes

Hi-5 & Hi-5 SX Software Update Package (SUP) 3.1.5

RELEASE NOTES

May 15th, 2025

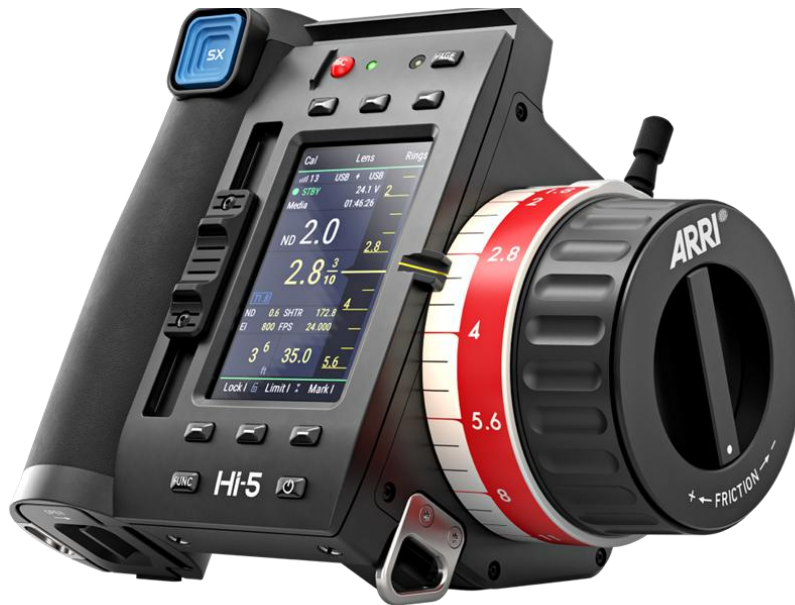
B.1. Hi-5 & Hi-5 SX SUP 3.1.5

This section describes changes from SUP 3.0 to SUP 3.1.5 for the Hi-5 and Hi-5 SX.

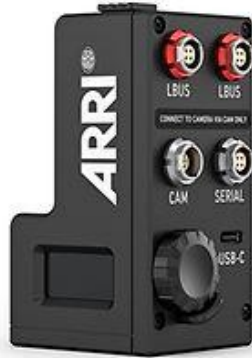
B.2. RIA-1 SUP 2.3.2

The RIA-1 SUP 2.3.1 is a compatibility and bugfix update to ensure that it works with the latest ECS features. In addition, it contains a few features and improvements that are listed below.

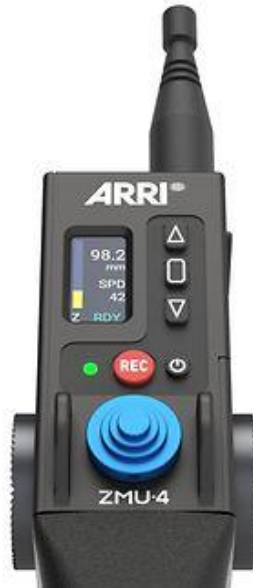
B.3. ZMU-4 SUP 1.3.2

The ZMU-4 SUP 1.3.1 is a compatibility and bugfix update to ensure that it works with the latest ECS features. In addition, it contains a few features and improvements that are listed below.

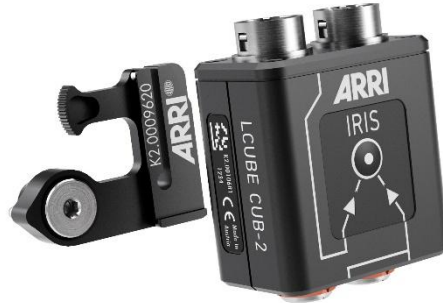
B.5.LCUBE CUB-2 SUP 1.3.1

The LCUBE CUB-2 SUP 1.3.1 is a compatibility and bugfix update.
