# ALEXA 35 ALEXA 35 Live

## Software Update Package SUP 4.1.0

### RELEASE NOTES

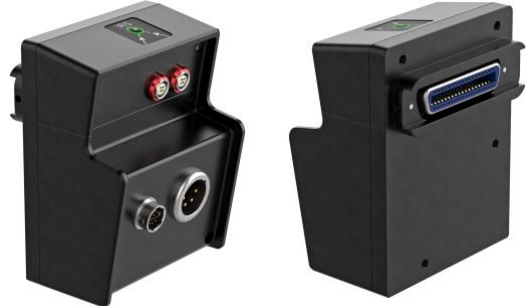
The LLA-1 Control Module is part of the ALEXA 35 Live - Multicam system and is mounted on the Large Lens Adapter LLA-1. It enables the connection of box lenses with a 36-pin Centronics connector—a standard interface for box lenses—to the camera, allowing control of focus, zoom, and iris via the camera or connected accessories.

The camera does not offer any specific settings, adjustments, or user-configurable options for the LLA-1 Control Module. The update is required to enable general compatibility with the module and ensure proper support within the system, so it is primarily intended for ALEXA 35 Live - Multicam system users and of less relevance to others.

For more information regarding the LLA-1 Control Module, please refer to the LPS-1 User Manual.
