LPS-1 Live Production System.

Software Update Package SUP 1.1.1

RELEASE NOTES

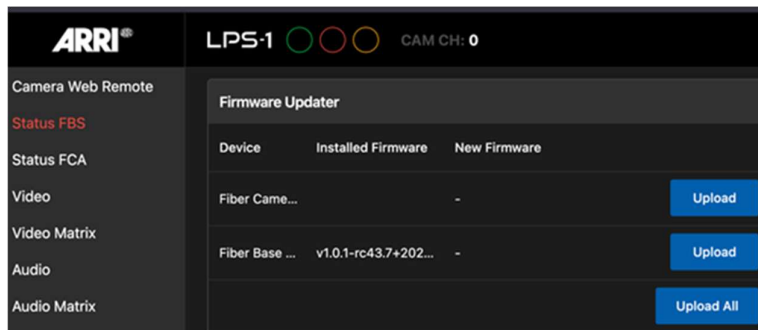
2. Ensure that the LPS-1 system is powered on, the Fiber Camera Adaptor has an active fiber connection to the Fiber Base Station and the system is fully booted.
3. Open the LPS-1 Web User Interface by entering the IP address of the FBS into the address bar of a web browser and navigate to the Settings page.
4. To update FBS and FCA together select *Settings > Firmware Updater* and click on 'Upload all' button. Browse to the location of the LPS-1_fw_1.1.1.raucb update file and select it.

To update only the FCA *Settings > Firmware Updater > FCA* and click on the 'Upload' button. Browse to the location of the LPS-1_fw_FCA_1.1.1.raucb update file and select it.
