Live Production System LPS-1

Software Update Package LPS-1 SUP 1.2.0

RELEASE NOTES

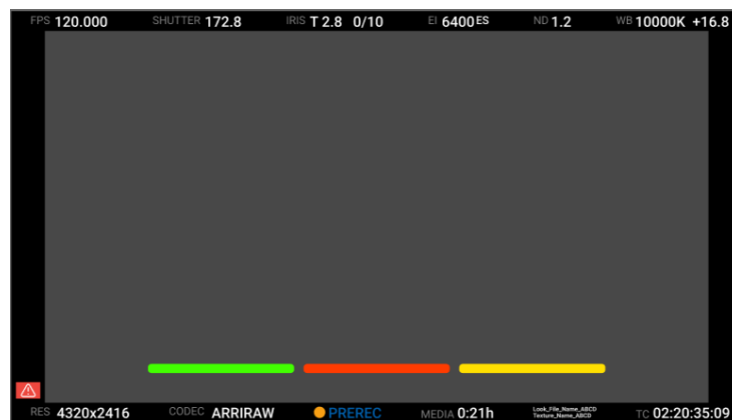
- Bug fixes and enhancements.
- LPS-1 Fiber Base Station Monitor Output Camera Status overlay can now be displayed as a surround replicating the viewfinder image and provide technicians with real time information on the camera parameters, settings and Tally status.

Furthermore, the Fiber Base Station Monitor output with overlay can then be looped back into the AUX/TP input of the base station and output from the Fiber Camera Adaptor to provide an SDI video connection to an additional monitor at the camera.

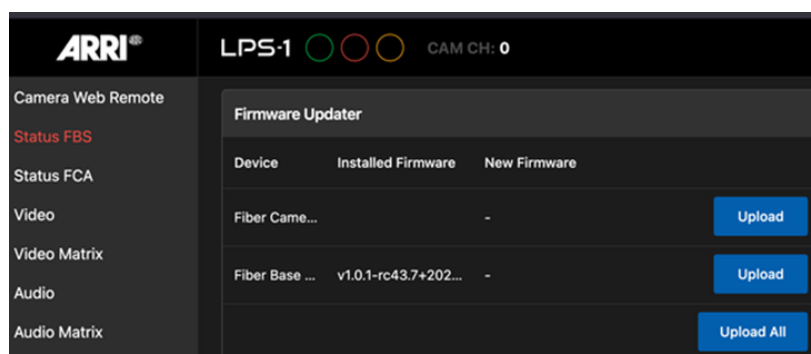
3. To update FBS and FCA together select *Settings > Firmware Updater* and click on 'Upload all' button. Browse to the location of the LPS-1_fw_1.2.0.raucb update file and select it.

To update only the FCA *Settings > Firmware Updater > FCA* and click on the 'Upload' button. Browse to the location of the LPS-1_fw_FCA_1.2.0.raucb update file and select it.
