ARRI Electronic Control System Release Notes

Hi-5 & Hi-5 SX Software Update Package (SUP) 3.3.0

RELEASE NOTES

December 18th, 2025

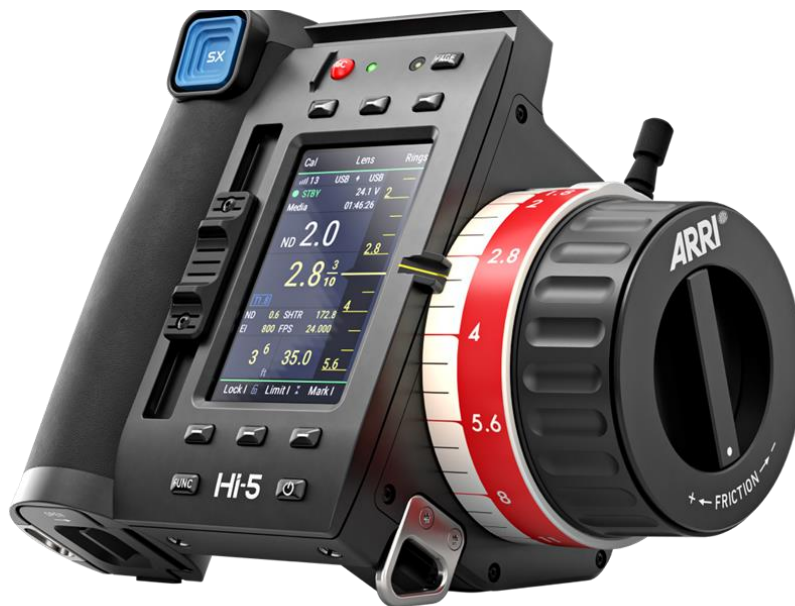
Support for ALEXA 35 Xtreme when connected to RIA-1, ZMU-4 or cforce mini RF

The recent Release of the ALEXA 35 Xtreme saw numerous new features introduced including new Resolutions, Sensor Modes and a new Codec. Hi-5 & Hi-5 SX now fully support all new Features. With SUP 3.2.1 those features worked when connected directly to an ALEXA 35 Xtreme they are now supported when the connection is done via other ARRI motor controllers like RIA-1, ZMU-4 or cforce mini RF.

Sensor Overdrive Indication

Active Sensor Overdrive is indicated in the FPS section on the Cam screen. If due to the chosen Recoding Resolution / Codex Compact Drive combination changes are not possible the respective Field is greyed out.

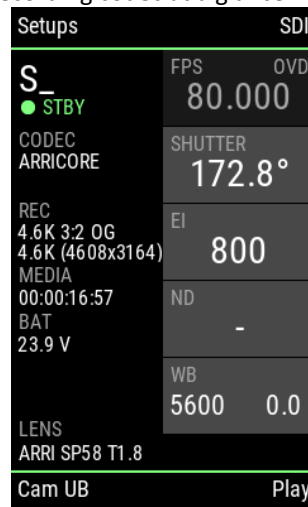
Sensor Mode and Recording Resolution display when connected to RIA-1, ZMU-4 or cforce mini RF

Even when connected via a RIA-1, ZMU-4 or cforce mini RF, Hi-5 now displays the active Sensor mode (upper line) and Recording Resolution (lower line) in a new segment titled REC. Due to space constraints Open Gate is abbreviated with 'OG'. This information is transmitted by all ALEXA 35 models running SUP 5.x or higher.

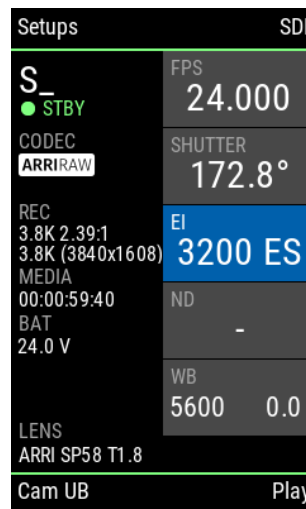
Enhanced Sensitivity Support when connected to RIA-1, ZMU-4 or cforce mini RF

Hi-5 now supports displaying and setting Enhanced Sensitivity on all ALEXA 35 models even when connected via a RIA-1, ZMU-4 or cforce mini RF. Please note that the camera must run at least SUP 5.0 to support this feature.

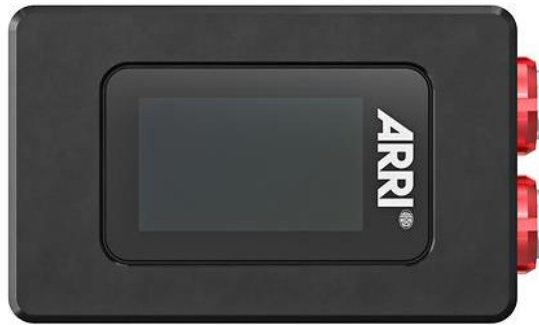
Sony Venice 2 Support

NIA-1 now supports the Sony VENICE 2. General Camera information as well User Buttons (Assignable 1-7) and Playback Control are now supported.

USB-C Link indication

When a device (PC or phone) with an active data connection is plugged into the USB-C Port of NIA-1 the status rectangle on that port now shows a green indication.

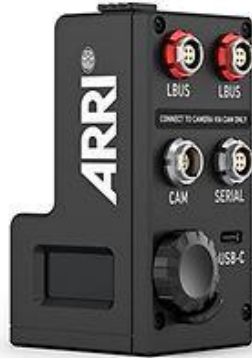
Support for additional Camera information

The RIA-1 now supports additional Camera Data over any Radio Module. Any ALEXA 35 model is now able to display and modify Enhanced Sensitivity values and shows the current Sensor Mode and Recording Resolution. An ALEXA 35 Xtreme also displays active Sensor Overdrive on any connected Hi-5.

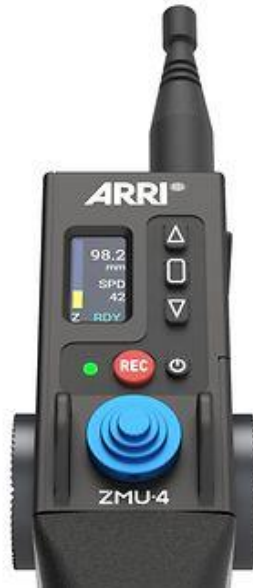
Support for additional Camera information

The ZMU-4 now supports additional Camera Data over any Radio Module. Any ALEXA 35 model is now able to display and modify Enhanced Sensitivity values and shows the current Sensor Mode and Recording Resolution. An ALEXA 35 Xtreme also displays active Sensor Overdrive on any connected Hi-5.

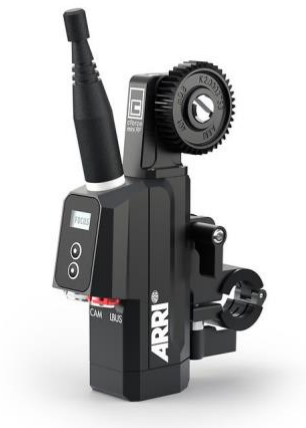
Support for additional Camera information

The cforce mini RF now transmits additional Camera Data wirelessly or within the LBUS chain. Any ALEXA 35 model now transmits Enhanced Sensitivity, the current Sensor Mode and Recording Resolution. An ALEXA 35 Xtreme also displays active Sensor Overdrive on any connected Hi-5.
