ARRI Electronic Control System Release Notes

Hi-5 & Hi-5 SX Software Update Package (SUP) 3.3.0

RELEASE NOTES

January 14th, 2026

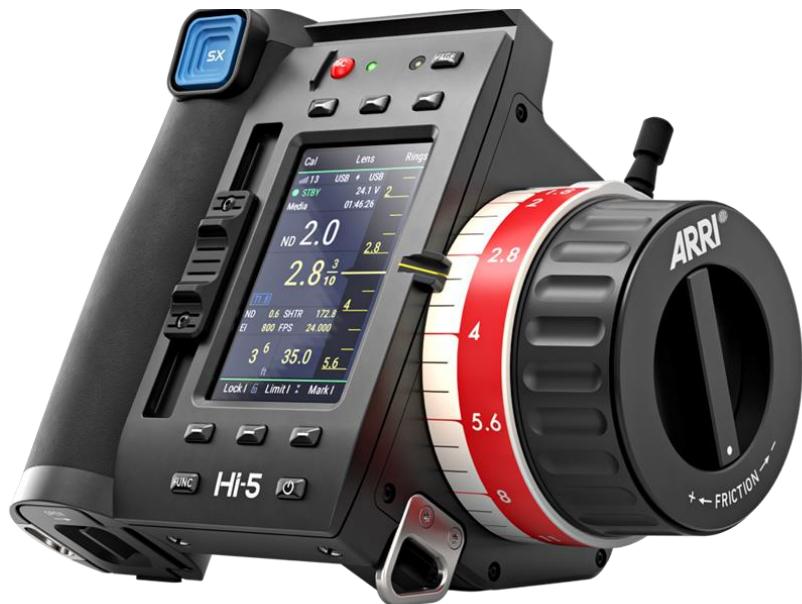
Support for ALEXA 35 Xtreme when connected to RIA-1, ZMU-4 or cforce mini RF

The recent Release of the ALEXA 35 Xtreme saw numerous new features introduced including new Resolutions, Sensor Modes and a new Codec. Hi-5 & Hi-5 SX now fully support all new Features. With SUP 3.2.1 those features worked when connected directly to an ALEXA 35 Xtreme they are now supported when the connection is done via other ARRI motor controllers like RIA-1, ZMU-4 or cforce mini RF.

Active Sensor Overdrive is indicated in the FPS section on the Cam screen. If due to the chosen Recording Resolution / Codex Compact Drive combination changes are not possible the respective Field is greyed out.

Like before the Cam page shows the active recording codec at a glance. ARRICORE is displayed here when selected.

Setups	SDI
S_	FPS OVD
● STBY	80.000
CODEC	SHUTTER
ARRICORE	172.8°
REC	EI
4.6K 3:2 OG	800
4.6K (4608x3164)	
MEDIA	ND
00:00:16:57	-
BAT	
23.9 V	
LENS	WB
ARRI SP58 T1.8	5600 0.0
Cam UB	Play

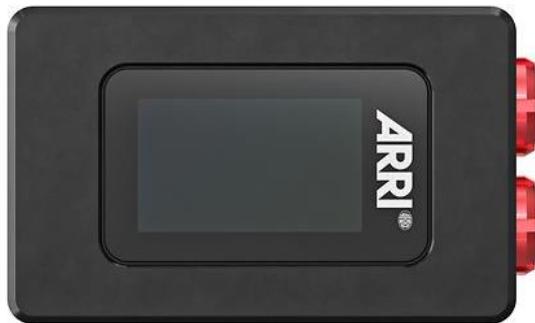
Sony Venice 2 Support

NIA-1 now supports the Sony VENICE 2. General Camera information as well User Buttons (Assignable 1-7) and Playback Control are now supported.

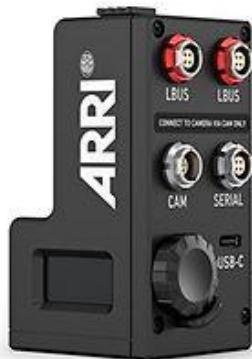
B.3. RIA-1 SUP 2.5.0

The RIA-1 SUP 2.5.0 is a compatibility and bug fix update to ensure that it works with the latest ECS features. In addition, it contains new features and improvements that are listed below.

The RIA-1 now supports additional Camera Data over any Radio Module. Any ALEXA 35 model is now able to display and modify Enhanced Sensitivity values and shows the current Sensor Mode and Recording Resolution. An ALEXA 35 Xtreme also displays active Sensor Overdrive on any connected Hi-5.

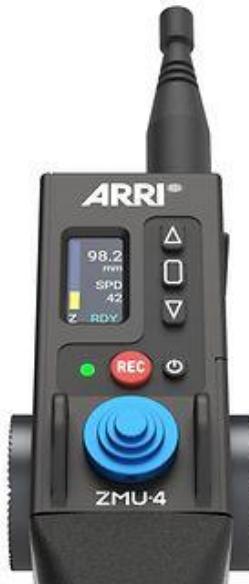
B.4. ZMU-4 SUP 1.5.0

The ZMU-4 SUP 1.5.0 is a compatibility update to ensure that it works with the latest ECS features. In addition, it contains a few features and improvements that are listed below.

The ZMU-4 now supports additional Camera Data over any Radio Module. Any ALEXA 35 model is now able to display and modify Enhanced Sensitivity values and shows the current Sensor Mode and Recording Resolution. An ALEXA 35 Xtreme also displays active Sensor Overdrive on any connected Hi-5.
