## ALEXA 35 Software Update Package 6.1.0

ALEXA 35 | ALEXA 35 Xtreme | ALEXA 35 Live | ALEXA 265

### RELEASE NOTE

D45 1000 6706 • K11784

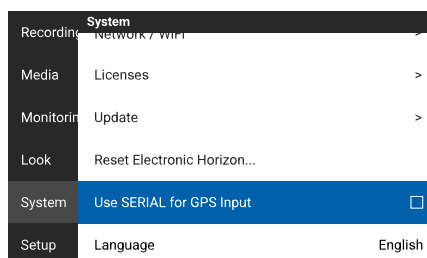
### GPS Metadata

You can configure the SERIAL connector of the camera to support a GPS module instead of a distance measurement device. The received GPS data (longitude, latitude, and altitude) is then transmitted to the camera and embedded as dynamic metadata into every recorded video frame. The GPS module needs to deliver NMEA 0183 v2.0 output and provide GGA, GSA, and GSV sentences. It shall communicate through true RS232 (not RS232-TTL) at a baud rate of 4800.

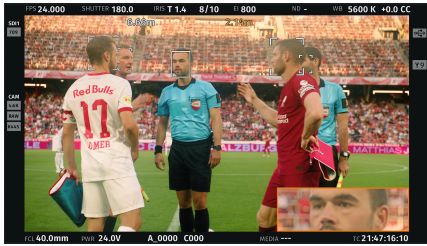
## Picture-in-Picture Tracking Zoom

Picture-in-Picture (PiP) Tracking Zoom works exactly like the Tracking Zoom. It automatically follows a selected person and keeps them centered in the frame to make it easier to focus and check for sharpness. Instead of switching the entire live image to a zoomed view, PiP Tracking Zoom keeps the full live image visible while simultaneously showing a zoomed section in a picture-in-picture overlay. This allows to maintain a complete overview of the framing while checking the focus in detail.
