# AMIRA SUP 5.4

Software Update Package SUP 5.4.13

RELEASE NOTES

Date: August 17<sup>th</sup>, 2018

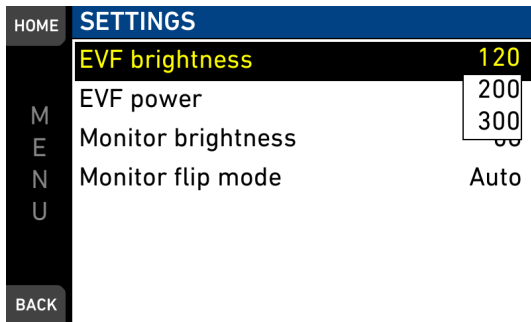
MENU > Monitoring > EVF/Monitor > Settings > EVF brightness

The panel comes with a new calibration and new brightness setting, with options 120, 200 and 300 Nits. EVF gamma is fixed and equivalent to the *Lifted* setting of the preceding viewfinder panel. The factory default brightness setting is 120 Nits. All existing MVF-1 will not be affected by this change, and will continue to function as before.

All AMIRA MVF-1 from serial no. 4000 onwards have a new OLED viewfinder panel built in, because the previously installed viewfinder OLED panel is no longer available. This new viewfinder panel will only display an image when used with SUP 5.4 and higher, and will not display an image with versions below SUP 5.4.
